Unusual Course after Double Valve Replacement

BecherH case 1

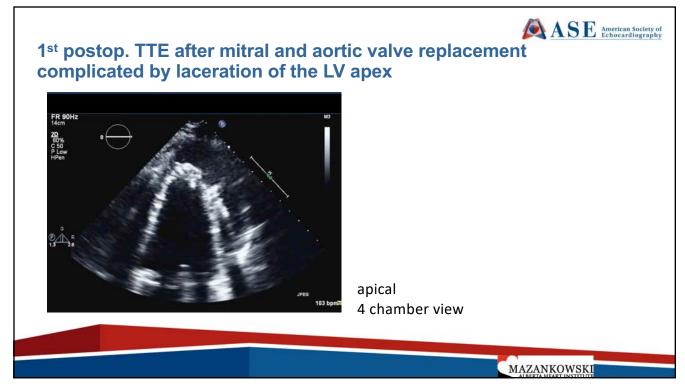
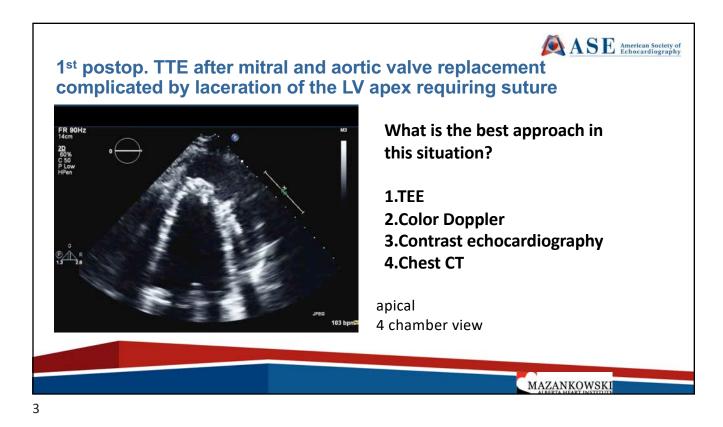
1st postop. TTE after mitral and aortic valve replacement complicated by laceration of the LV apex requiring suture
