A Potpourri of Fascinating Cases to Learn From

Bonita Anderson

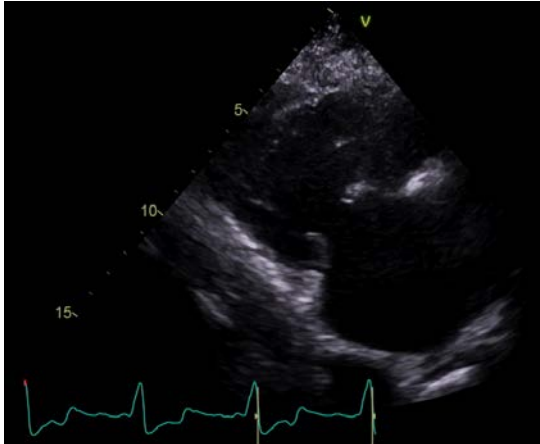
10

70 yo male post-pacemaker lead extraction + new leadless device insertion

This is likely:

1. A large tricuspid valve vegetation
2. A ruptured papillary muscle
3. Entrapped thrombus within the tricuspid apparatus
4. Traumatic tricuspid valve injury

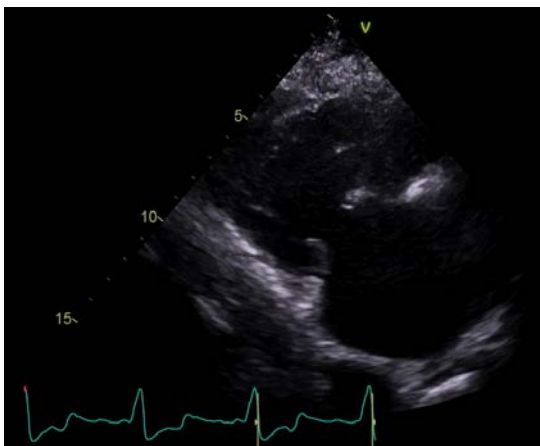
11

70 yo male post-pacemaker lead extraction + new leadless device insertion

This is likely:

1. A large tricuspid valve vegetation
2. A ruptured papillary muscle
3. Entrapped thrombus within the tricuspid apparatus
4. Traumatic tricuspid valve injury

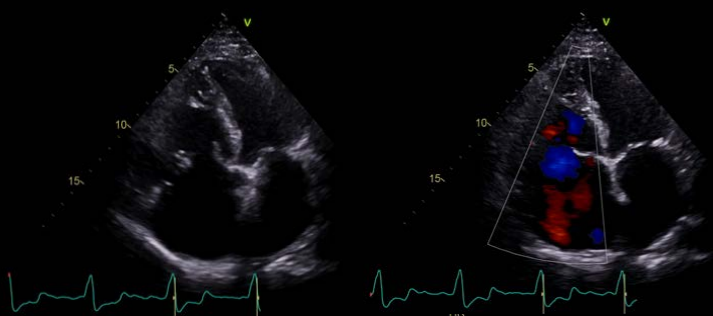
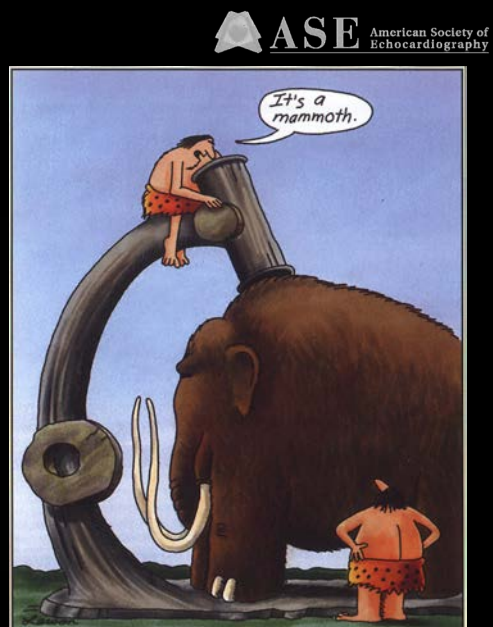
16

Did we need HV Doppler to confirm this patient has severe TR?

- Doppler profiles of TR & HV assist in determining TR severity.

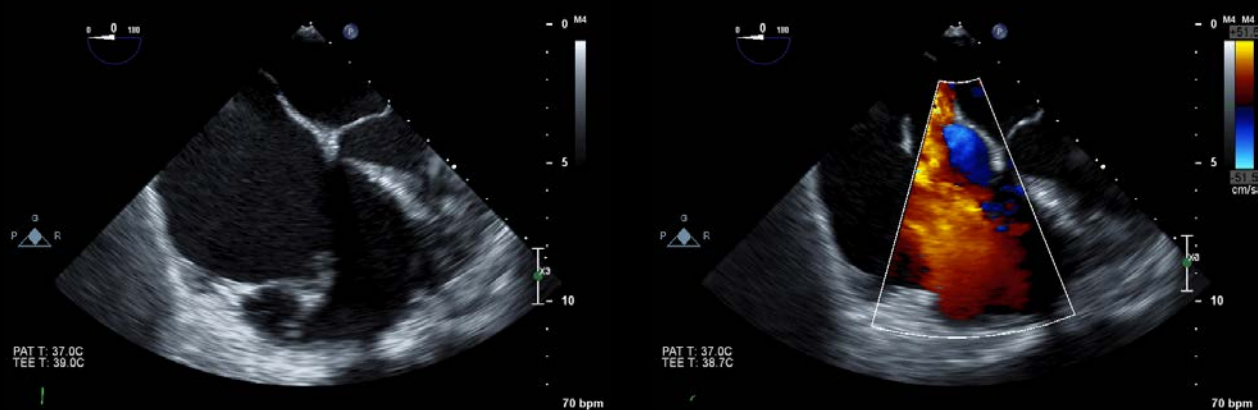
17

Intraoperative TEE

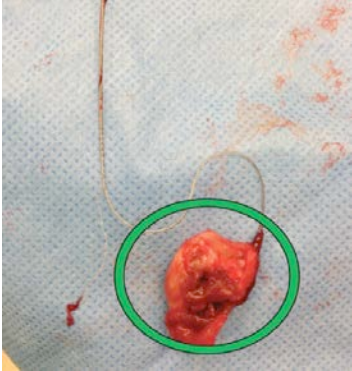
21

From Patel B, Daraghme A, Machado C. Severe tricuspid valve regurgitation requiring surgical intervention as a result of pacemaker lead extraction: a case series. J Innov Cardiac Rhythm Manage. 2014;5(2):1525-1529; With permission

Traumatic TV injury post-lead extraction

- Incidence 3.5% to 12%
- Partial avulsion usually evident immediately after lead extraction
- Requiring surgery rare
