# Recommendations for the Identification and Mitigation of Cardiac Ultrasound Artifacts: A Guideline from the American Society of Echocardiography

An ultrasound artifact is a feature in an ultrasound image that does not accurately represent the true anatomy or pathology. Cardiac ultrasound artifacts are common and inevitable findings as they originate from the physical properties of ultrasound. Additionally, artifacts may occur due to interference from external equipment and devices producing ultrasound waves. This document provides a uniform and structured approach to managing ultrasound artifacts, including the appearance of the artifact on the image, the mechanism behind the artifact generation, the clinical impact of the artifact on the diagnosis and management of the patient, examples of real cases, and how the artifact can be avoided or mitigated. In addition to true artifacts, we also discuss a series of artifact-like phenomena. Everyone involved in performing or interpreting cardiac ultrasound should be familiar with artifacts and their potential for misdiagnosis, which in some instances may lead to serious clinical consequences. Despite continued improvements in ultrasoun

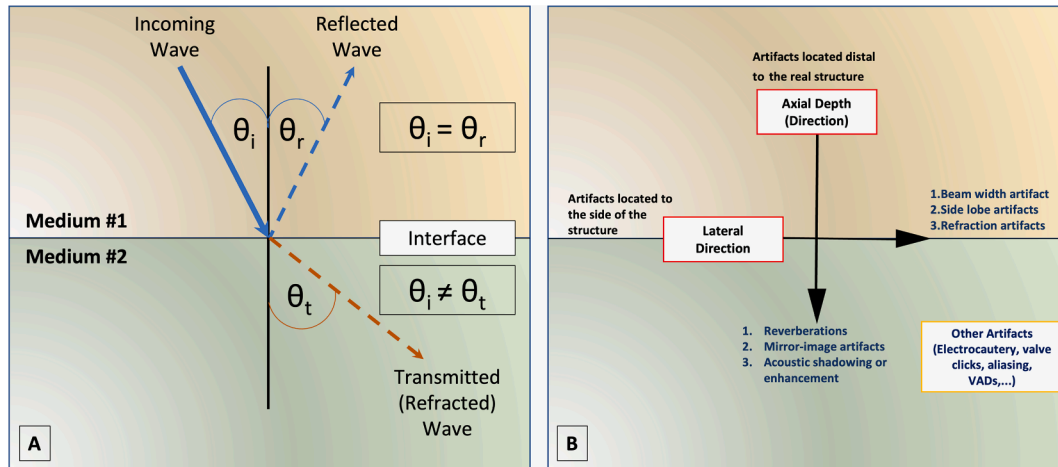
**Figure 1** Ultrasound image generation and artifacts categorization. **(A)** Basics of 2D image generation. Ultrasound waves created by the transducer strike the interface between medium 1 and 2 (blue arrow) at an angle called the angle of incidence ( $\theta_i$ ). Ultrasound waves are partly reflected (blue dotted arrow) and usually mostly transmitted to medium 2 (red dotted arrow). If there is an oblique incidence and a significant difference in propagation speeds between the 2 media, the transmitted wave is bent (refracted). **(B)** Schematic illustration of assumption violation artifacts based on location relative to the true image.

Violation of 1 or more assumptions may result in the formation of artifacts in a predictable manner. Ultrasound assumption violation artifacts can be categorized based on their location in relation to the real structure. Axial artifacts are located distal to the real structure and are subcategorized into reverberation, mirror image, acoustic shadowing, enhancement artifacts, and speed displacement artifacts. Lateral direction artifacts are located to the side of the real imaged structure and are subcategorized into side lobe, beam width, and refraction artifacts (Figure 1B). In addition to ultrasound system assumption violations within native tissue, some artifacts arise due to interaction with a variety of foreign objects, including wires, catheters, devices, and external equipment.

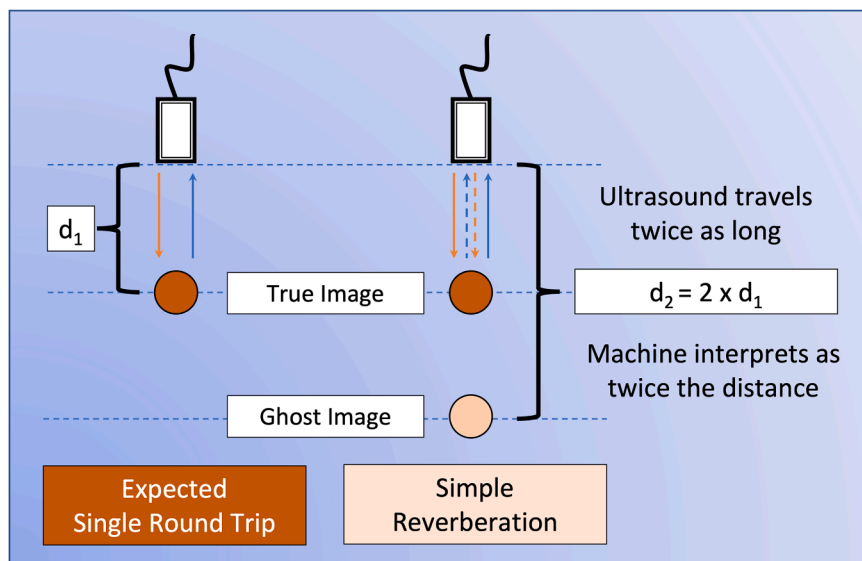
**Figure 2** Basics of simple reverberation artifact. Ultrasound systems assume that wave travels back to the transducer after a single round trip and interpret the true image (red circle) to be at the distance ( $d_1$ ) calculated on the basis of this rule. In simple reverberation artifact, this rule is violated; the ultrasound wave travels one more time between the strong reflector and the probe itself (as shown in this diagram). The transducer interprets another image (pink circle) as being twice as deep ( $d_2 = 2 \times d_1$ ).

**Appearance in image.** The ultrasound system maps the original structure as a true image with the correct distance and the artifactual image (ghost image) distal to the original structure at twice the distance (Figure 2).

**Mechanism.** The ultrasound system measures the time interval between the sent and received signal (travel time or time of flight) to determine the distance between the transducer and the actual structure. Simple reverberation artifacts occur when the ultrasound pulse makes 2 round trips to the target tissue

and the ultrasound system interprets it as a longer travel time and generates an artifactual image twice as deep as the actual image. This occurs when the ultrasound pulse encounters a second strong reflector on its return to the transducer. The first reflector is the target tissue. The second reflector may be the transducer itself or some other strong reflector near the transducer, such as calcifications or implanted devices.

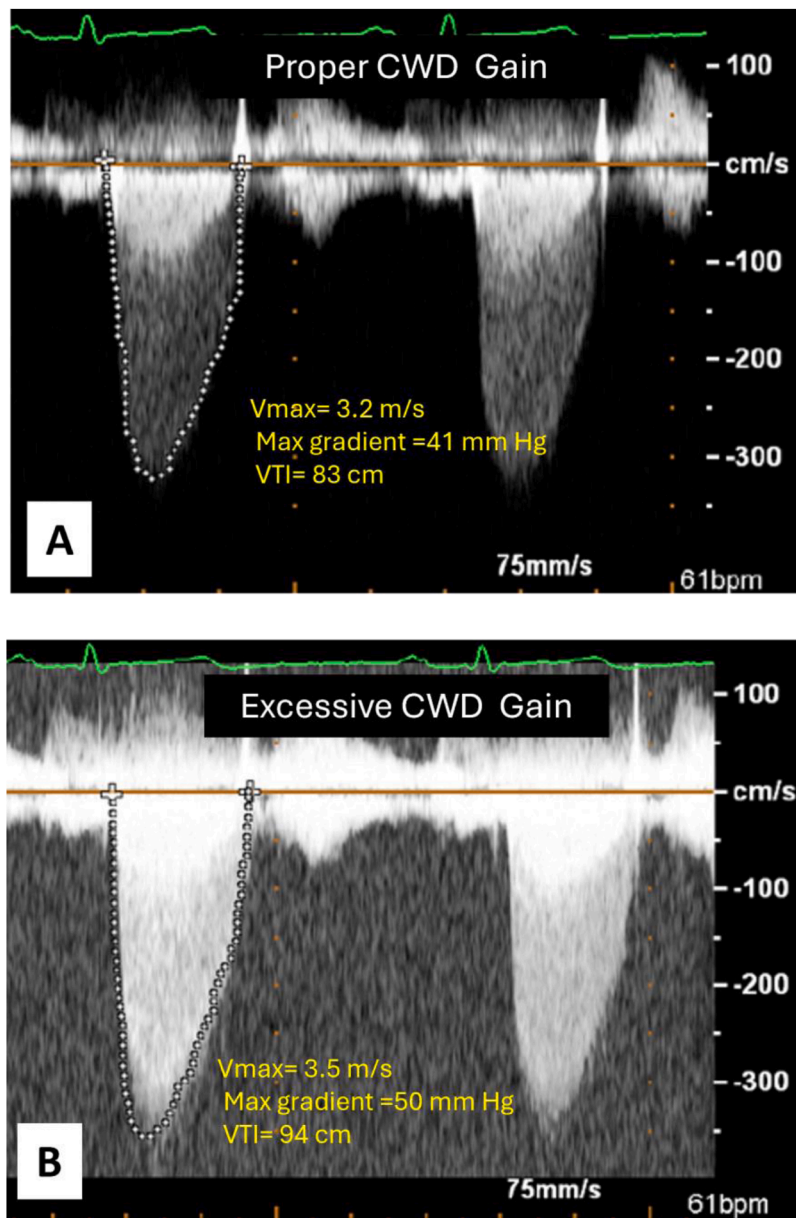
**Figure 16** Spectral Doppler overgain. CWD study of the aortic valve. **(A)** Proper CWD Gain. **(B)** Excessive CWD gain resulting in falsely elevated peak aortic valve velocity. *Vmax*, Maximum velocity; *VTI*, velocity-time integral.

**Appearance in image.** Overgaining can cause excessive noise and a brighter signal, while undergaining can result in a less bright signal and missing low-amplitude information (Figure 15). The measured peak velocity of a jet of tricuspid regurgitation (TR) or aortic stenosis may be falsely elevated due to an overgained CWD signal (Figure 16, Video 16).

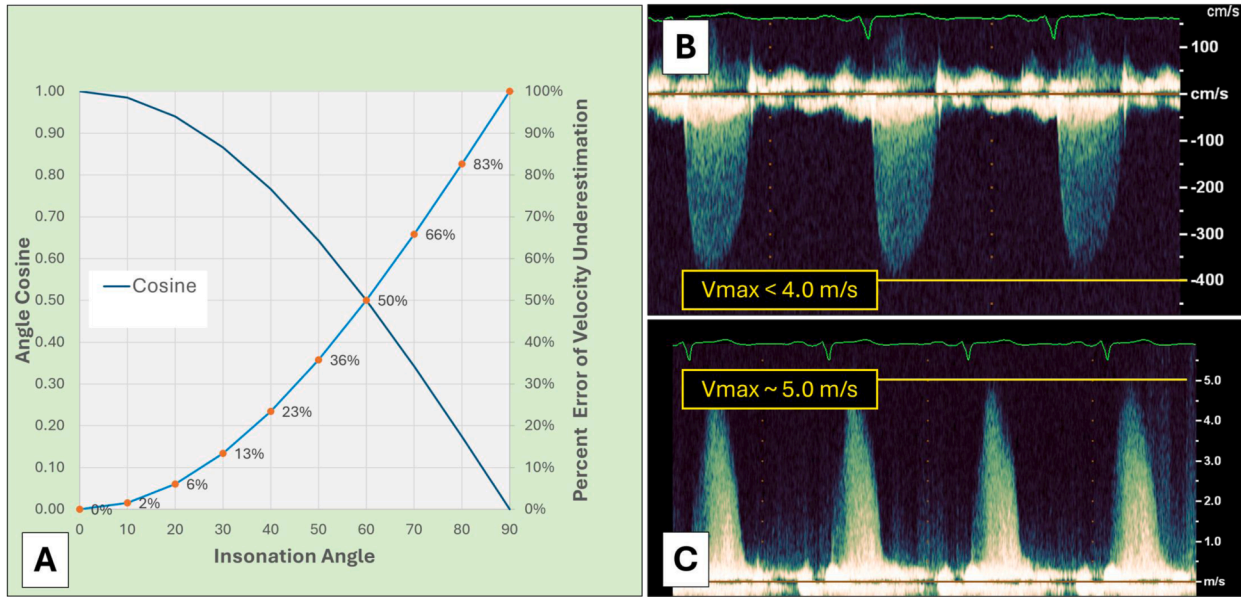
**Figure 19** Spectral Doppler insonation angle error. **(A)** Spectral Doppler insonation angle error is inversely related to the cosine of the insonation angle ( $\theta$ ). When the angle increases from  $0^\circ$  to  $90^\circ$ , the cosine decreases from 1 to 0. The recorded velocity is maximal at  $0^\circ$ , is significantly lower when the insonation angle is  $60^\circ$  or greater, and when the probe is perpendicular to the flow ( $\theta = 90^\circ$ ) no velocity is recorded. **(B)** CWD recording from the apical five-chamber view underestimates the degree of aortic stenosis compared with **(C)**, which demonstrates recordings from the right parasternal window having a more coaxial insonation angle to aortic flow.

**Appearance in image.** A noncoaxial intercept angle Doppler artifact has no specific appearance other than underestimating the true velocity compared to other recordings. The aortic valve peak velocity is underestimated when the Doppler beam is not coaxial with the aortic flow. This is the reason why aortic stenosis recordings should be obtained from multiple windows.<sup>28</sup> This artifact occurs with both PWD and CWD (Figure 19).

**Mechanism.** Based on the Doppler equation, when the ultrasound beam and blood flow direction are coaxial ( $\theta = 0^\circ$ ),  $\cos(\theta)$  is 1 and maximum velocity is recorded. As the Doppler intercept angle (between the ultrasound beam and the blood flow,  $\theta$ ) increases from  $0^\circ$  to  $90^\circ$ , the cosine of  $\theta$  decreases from 1 to 0. This leads to a progressive decrease in the maximum velocity measured (relative to the actual velocity) until no velocity is detected when the angle is  $90^\circ$ .

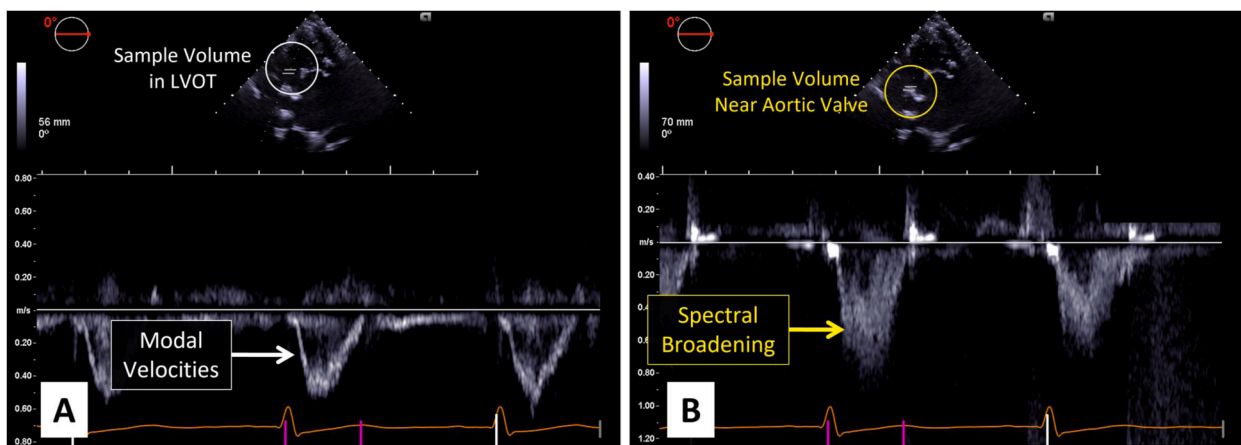
**Figure 20** Spectral Doppler broadening. **(A)** PWD LVOT recording with appropriate modal velocities (white arrow). **(B)** Spectral broadening of the LVOT signal prevents accurate LVOT velocity measurements (yellow arrow).

For instance, when evaluating aortic stenosis, the maximum velocity is measured at the outer edge of the brightest signal; fine linear signals at the peak of the curve are due to transit-time effects and should not be included in measurements. The fine linear signals of the Doppler signal may be referred to as the beard, while the true flow velocity outline is referred to as the chin. **Figure 20** demonstrates the broadening of the LVOT PWD signal.

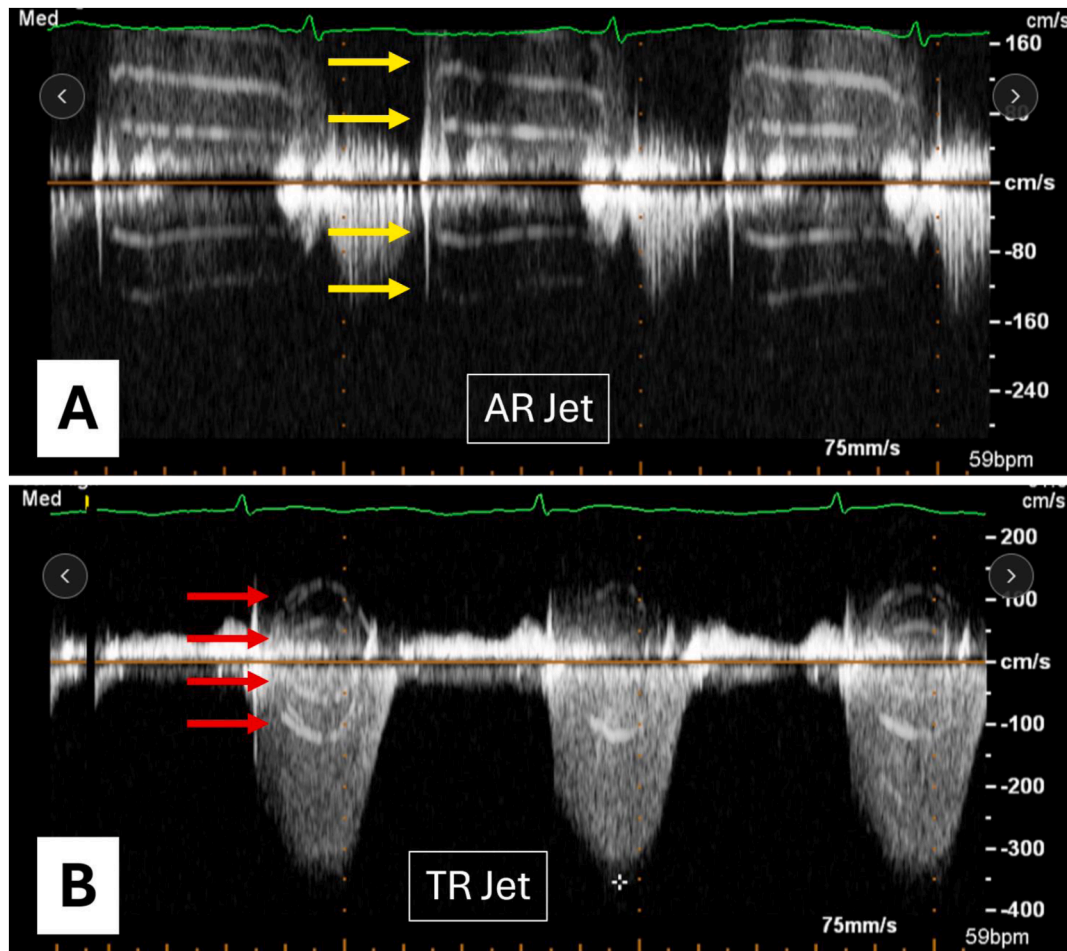
**Figure 22** Tiger stripes artifacts. Two-dimensional TTE CWD imaging of the aortic valve (A) and the tricuspid valve (B). The repetitive bandlike images (*arrows*) are noted on both sides of the baseline because the emitted ultrasound beam hits an oscillating intracardiac structure. The first band closest to the baseline represents the lowest (fundamental) frequency of the oscillating structure, while the other bands represent harmonic overtones.

**Appearance in image.** Tiger striping refers to alternating bright and dark parallel lines on both sides of the Doppler waveform that resemble a tiger's stripes. Tiger stripes may occur with both PWD and CWD recordings. Tiger stripes have been reported with Doppler recordings of native valve regurgitations, flail prosthetic valve

leaflets, intracardiac mobile masses such as ruptured papillary muscle, and Lambd's excrescences, and even with pacemaker leads (Figure 22).

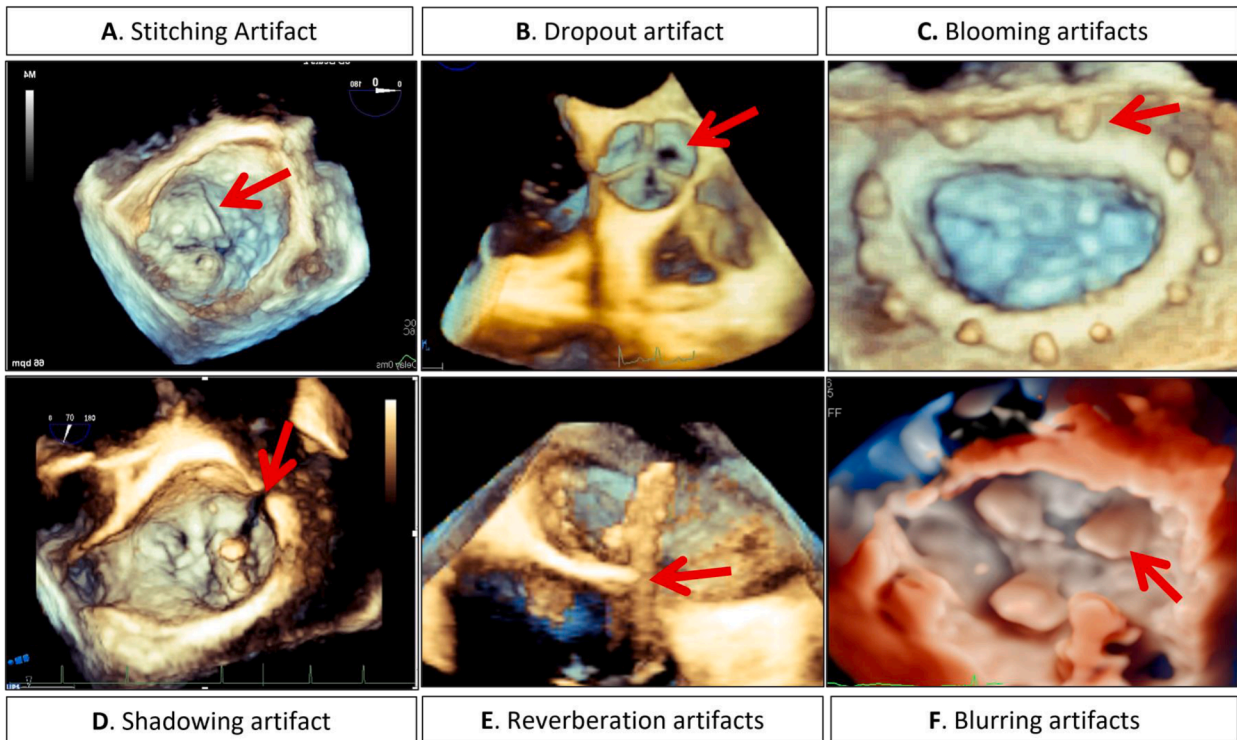
**Figure 33** Three-dimensional artifacts. Common 3D echocardiography artifacts. **(A)** Stitching artifact of a native mitral valve. **(B)** Dropout artifact of a native aortic valve. **(C)** Blooming artifact of a prosthetic annuloplasty ring. **(D)** Shadowing artifact in the left atrium by a mitral clip. **(E)** Reverberation artifact in the left atrium by a catheter. **(F)** Blurring artifact of mitral bioprosthetic struts.

leaflets do not occur in systole since the body of the leaflet is perpendicular to the ultrasound beam and generates strong echoes. Unlike dropouts, true holes demonstrate expected physiologic flow through them on color Doppler imaging (Figure 33B). The most common dropout artifacts occur in the foramen ovale of the interatrial septum, simulating atrial septal defect, and in the aortic and tricuspid leaflets, simulating leaflet perforations.<sup>55-57</sup>

**Appearance in image.** In the assembly process, thin and elongated structures may appear with indistinct edges and increased size in those perspectives that use lateral rather than axial resolution. Calcifications and metallic structures (e.g., prostheses or guidewires) produce fringes that surpass the borders of the structure. This phenomenon is called blooming.<sup>55-57</sup> A blooming artifact of a mitral annuloplasty ring is shown in Figure 33C. Blurring artifacts of the bioprosthetic strut are shown in Figure 33F.

**Appearance in image.** Shadowing artifacts cause dropouts that resemble a lack of tissue distal to a catheter/device. It can be recognized by its position, as well as its similar shape, size, and motion to the catheter. Three-dimensional shadowing by a mitral clip and reverberation artifacts by a catheter are shown in Figure 33D and E.

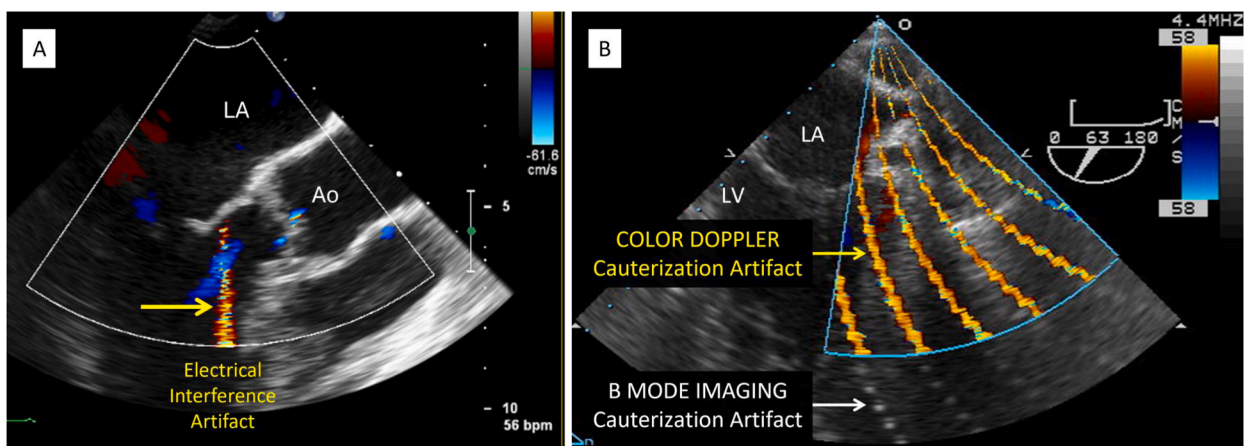
**Figure 36** Electrical and cauterization interference. **(A)** Color Doppler study during 2D TEE demonstrates the artifact due to electrical interference (yellow arrow) from unshielded electrical appliances or a broken probe. **(B)** Cauterization artifact on B-mode (white arrow) and color Doppler (yellow arrow) imaging. Ao, Aortic valve; LA, left atrium; LV, left ventricle.

**Appearance in image.** An electrical artifact is easily recognized as a geometric shape that does not stay within the borders of the cardiac structures and appears in all windows while the electrical equipment is still on. External electrical signals can create a band within the 2D and color Doppler imaging sectors (Figure 36A). External cautery, as used in the operating room, causes a fan-shaped artifact that is seen throughout the ultrasound image without respecting chamber boundaries (Figure 36B, Video 24).

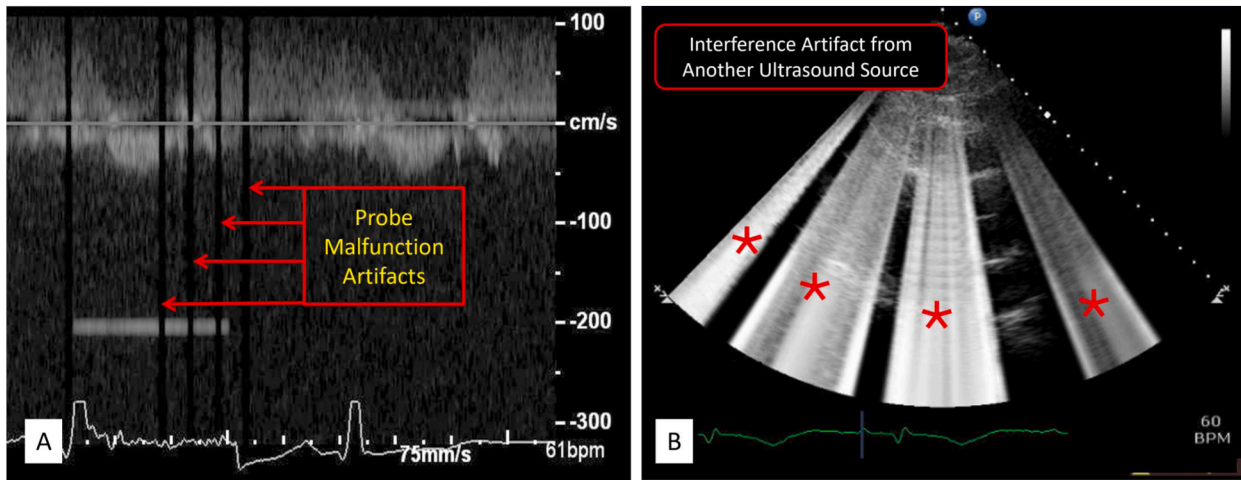
**Figure 37** Probe malfunction and crosstalk interference. **(A)** Spectral Doppler interrogation of the tricuspid valve during TEE demonstrates intermittent dark vertical lines through the tracing, suggesting probe malfunction (*red arrows*). **(B)** Crosstalk interference artifact happens when ultrasound waves from two different sources interact to create an artifact. This TTE parasternal long-axis view demonstrates fanlike artifacts (*red asterisks*) caused by interaction with a second ultrasound source used for ultrasound-assisted thrombolysis of pulmonary thromboembolism.

**Appearance in image.** Irregular and repetitive echoes occur throughout the image. Regardless of the probe used, all images in all views will demonstrate this artifact (Figure 37B, Video 25). Cross talk artifacts may be caused by the simultaneous use of both TEE and intracardiac echocardiography during transcatheter procedures. Other causes include simultaneous use of vascular ultrasound for arterial or venous access during TTE or TEE in patients with pulmonary embolism receiving ultrasound-enhanced catheter-directed thrombolysis.
